PROJECT REPRESENTATIVE'S DAILY REPORT

Pg. 1
Report No. 050
Date: 2014-10-28
Day: Tuesday

Project: Renovation and Addition to Tewksbury Town Hall

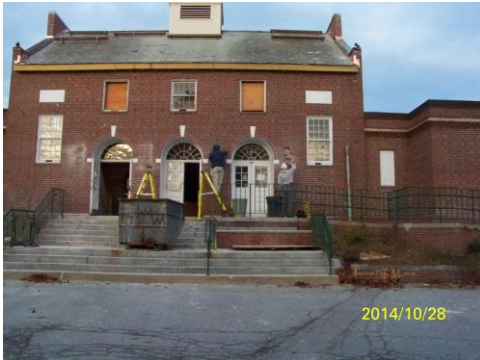
Photo showing masons working on brick infills on the east elevation.

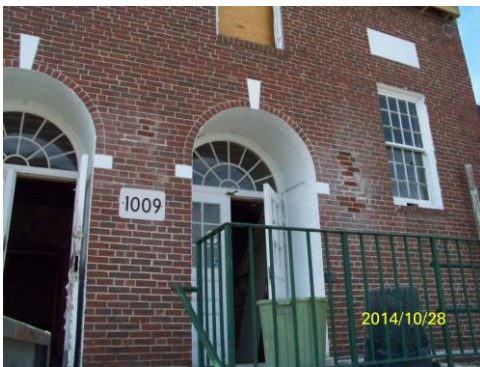
Photo showing the bricked in areas. These locations have not been cleaned or washed down.

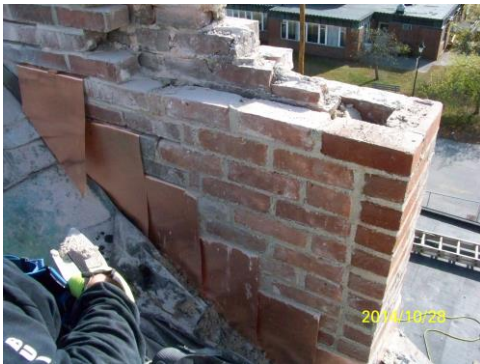
Photo showing the chimney area being bricked in along with new step flashing.

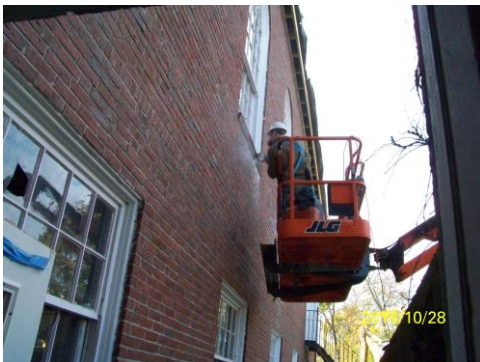
Photo showing mason cutting out joints on the north elevation of the meeting hall.

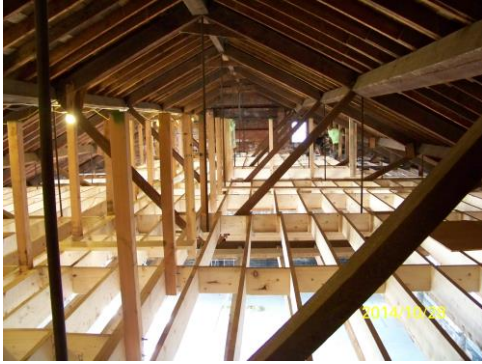
Photo showing the framework in the attic under way.

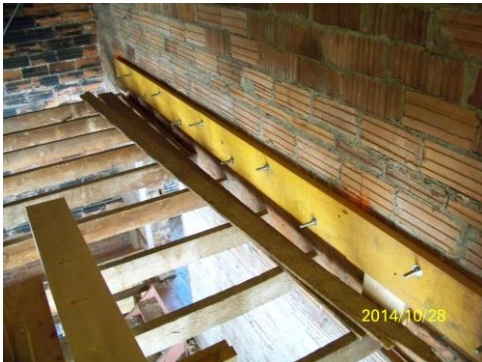
Photo showing new framing installed in the attic.

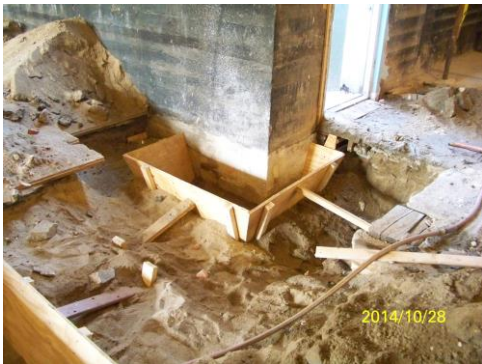
Photo showing footing formwork in place. This is at the corner of the north wall of the meeting hall and the west wall of the north wing.

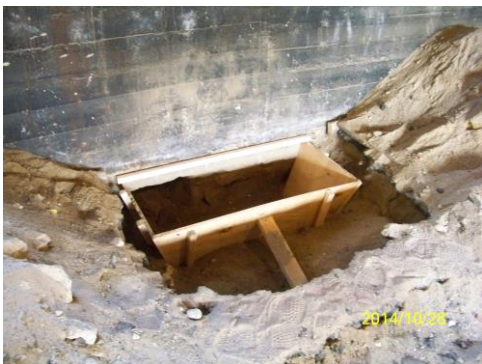
Photo showing footing formwork in place along the north wall of the meeting hall.
